NASA Contractor Report 179537
Garrett 21-5278-1

Oxide-Dispersion-Strengthened Turbine Blades

P.P. Millan, Jr. and J.C. Mays
Garrett Turbine Engine Company
Phoenix, Arizona

October 1986

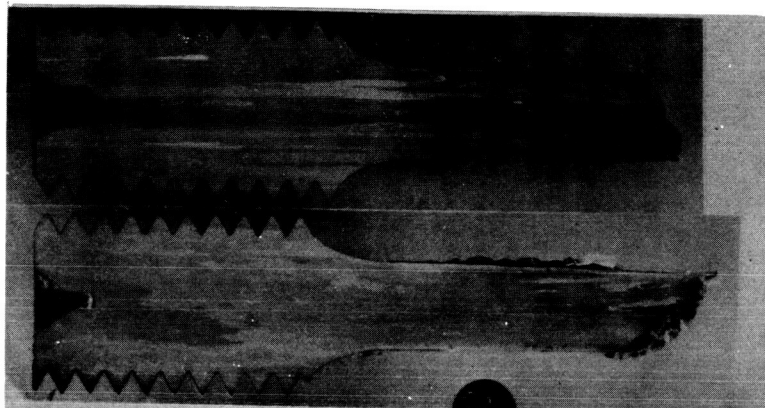
(a)

43 Percent/1066C (1950F), Tests 37623 (top) and 37604 (bottom)

Figure 7. Polished and Etched (Glyceregia) Sections of Stress Rupture Specimens Revealing Typical Grain Structure of Laboratory Scale MA6000, Except for Specimen (g). (2X)

The high-extrusion-ratio material exhibited generally superior rupture strength over the low-extrusion-ratio material. The strength of the former is 154 MPa (22.3 ksi) for 100-hour life, which is 5 MPa (0.7 ksi) better than the low-extrusion-ratio material. This difference may, in fact, be due to the extrusion ratio or to normal variations in the powder makeup of each extrusion. In any case, the strength for each extrusion ratio exceeds the project goal of 138 MPa (20 ksi) for 100-hour life.

Thus, the best 1093C (2000F) rupture strength was obtained for the TMP combination with the higher extrusion ratio (13.6:1); the higher extrusion temperature, 1038C (1900F); the lowest rolling reduction (45 percent); and the higher rolling temperature, 1066C (1950F). Material produced by this optimum TMP combination exhibited an average estimated 100-hour rupture strength of 154 MPa (22.3 ksi), greatly exceeding the goal of 138 MPa (20 ksi).
